## **INNOVATIVE TECHNOLOGY DEMONSTRATION**

# ***Enhanced Stabilization of Dikes and Levees Using Advanced ElectroKinetic Technology***

December 2006

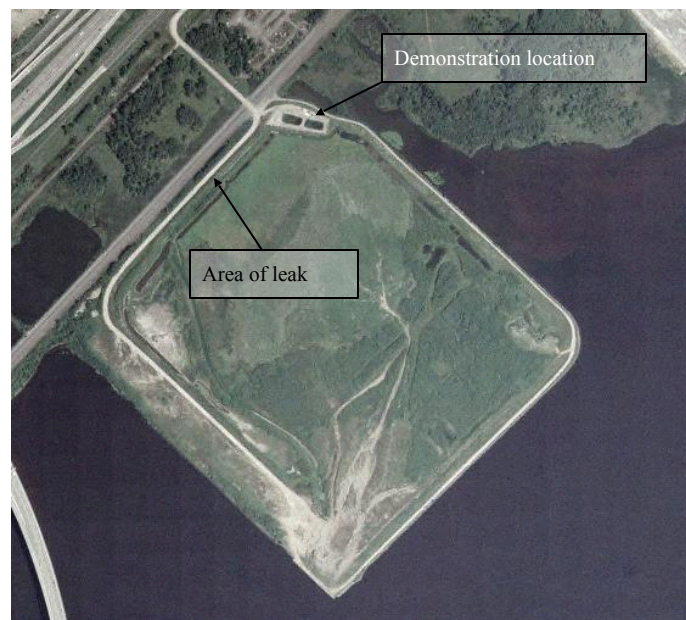
**Figure 1.** Erie Pier CDF

The Erie Pier Confined Disposal Facility (CDF) is located in the Port of Duluth- Superior and is the repository for sediments dredged from the harbor. An aerial view of the CDF is shown in Figure 1. Two items are identified in the picture. The first is the location at the top (north) corner of the CDF where the demonstration took place. The second is the perimeter berm that surrounds the CDF and contains the dredged material placed in the CDF. The road girdling the CDF is at the outside base of the containment berm. The berm to the southwest of the demonstration location was leaking, and the electrokinetic process was suggested as a possible method of plugging the leak.

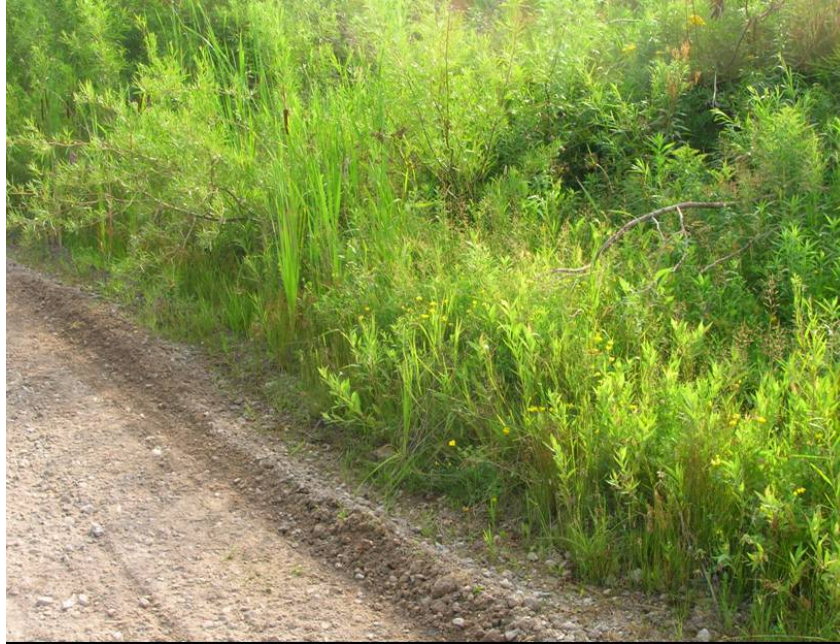
**Figure 2.** Area along the CDF where leakage was occurring

The photograph in Figure 2 was taken at the location along the berm of the CDF where leakage was observed. A onsite visit the previous winter also showed considerable ice build-up at the base of the berm; during the summer, seepage water was observed along the road at the same location.

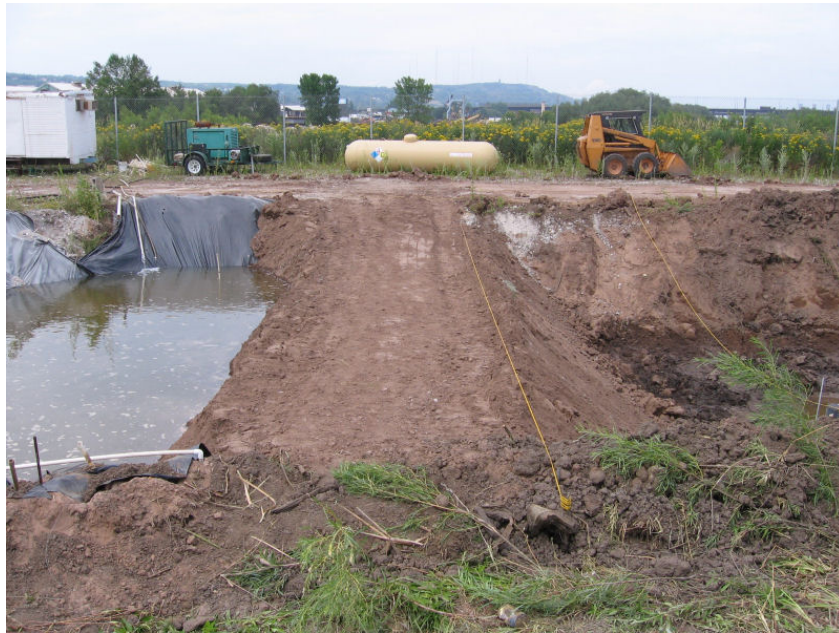
Following construction, the pool behind the dike was filled with water and allowed to sit for several days until the dike began to “leak”. The completed dike measured approximately 40 feet long, 6 feet wide at the top, 18 to 20 feet wide at the base, and 6 feet high. The dike material’s angle of repose was approximately 40°. Figure 5 shows

the completed dike and pool, with the Uni-Loader in the background. Actual moisture content and compaction densities were not measured during dike construction.

**Figure 5.** Completed dike and pool, with loader in the background (to the right of the propane tank).

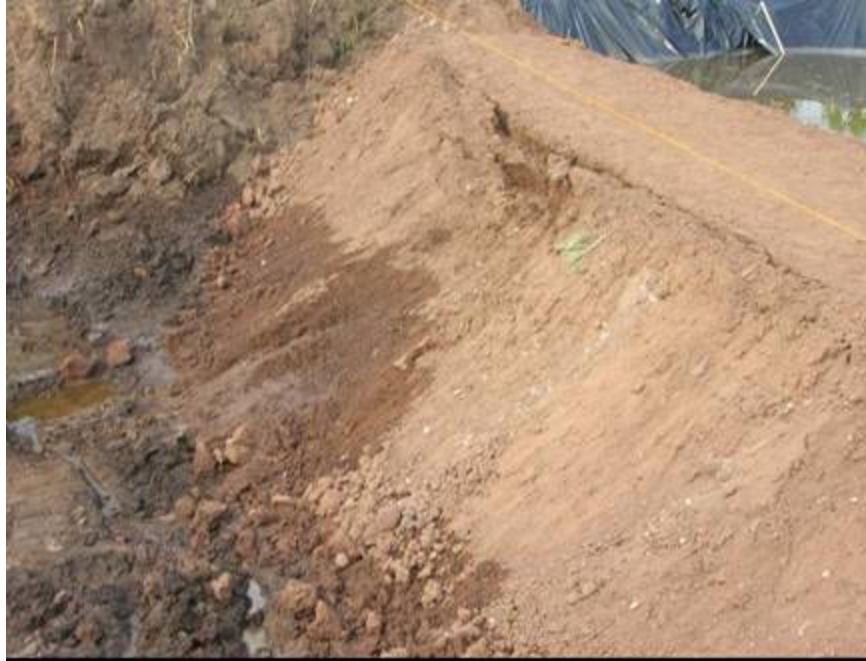
As constructed, the dike was anticipated to have sufficient water seepage for the test, and it did, as Figure 8 shows. The pool was equipped with a float valve (Fig. 9) that controlled a water supply pump to maintain a nearly constant water level on the pool side of the dike.

**Figure 8.** Wet areas along dike showing initial seepage/leakage.

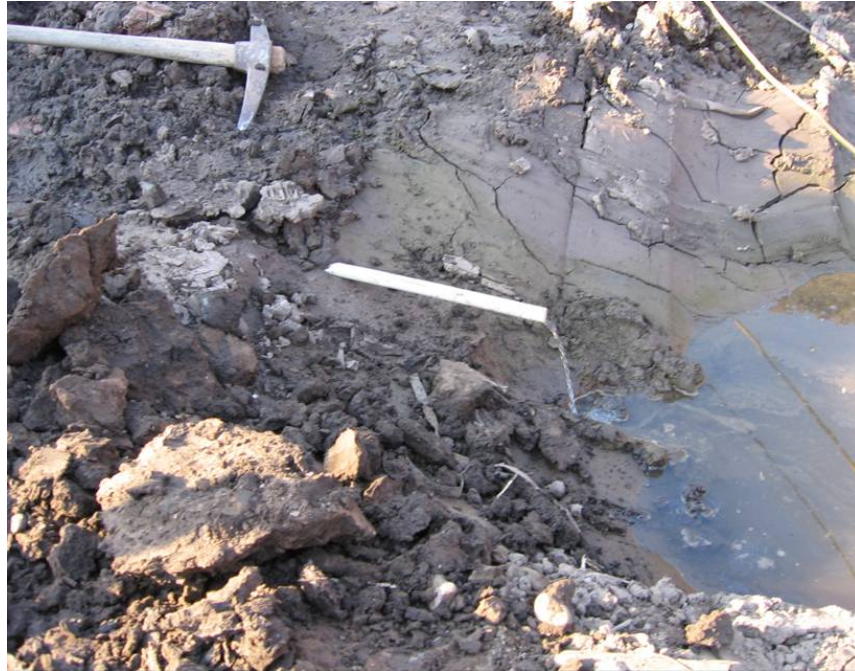
- Leakage rate was measured several times a day by diverting the leakage through the face of the dike with a small dam networked to a common exit point (Fig. 11). The leakage rate was measured by timing the flow of liquid into a graduated beaker.

**Figure 11.** Exit point for collecting leakage rate from the face of the dike.

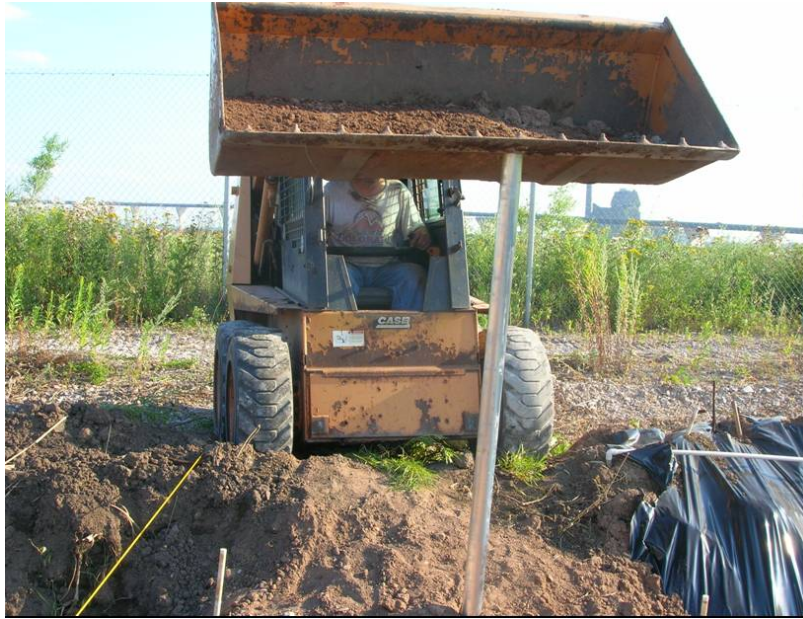
The anodes, made of 10-foot long heavy walled aluminum pipes, were installed with a Case Uni-Loader. The loader was used to direct-push the anodes into the dike, as shown in Figure 14. The cathode, a 15-foot long steel tube, was fitted with a wooden point and driven into the dike with a come-along winch and blows from a sledge hammer. The cathode was perforated with three rows of holes along its length to facilitate drainage of water from the dike.

**Figure 14.** Direct-push installation of aluminum anodes

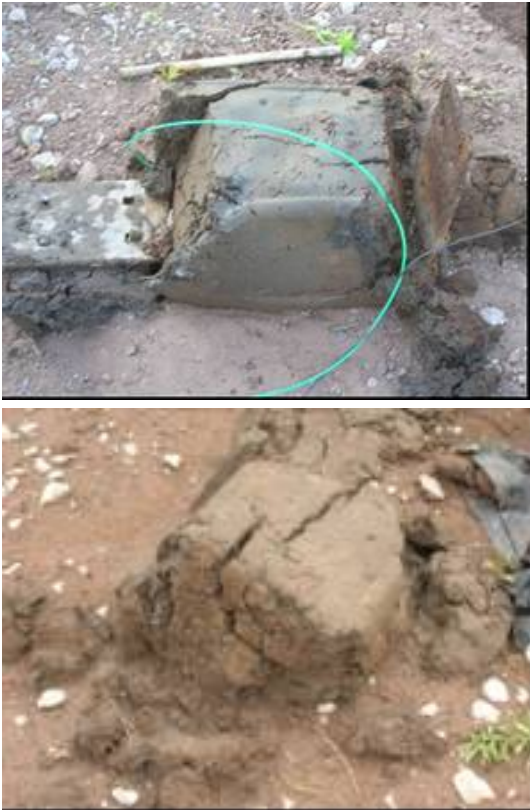
The intense rain also provided an opportunity to illustrate the stabilizing effects of electrokinetics at a smaller scale. Previously saturated and unstable silty material that had been electrokinetically dewatered during a concurrent ex-situ silt dewatering demonstration<sup>1</sup> and left exposed to the weather maintained its form despite being subjected to the heavy on-site rainfall, as shown in Figure 19.

**Figure 19.** Material after initial removal    Material after 5 inches of rain

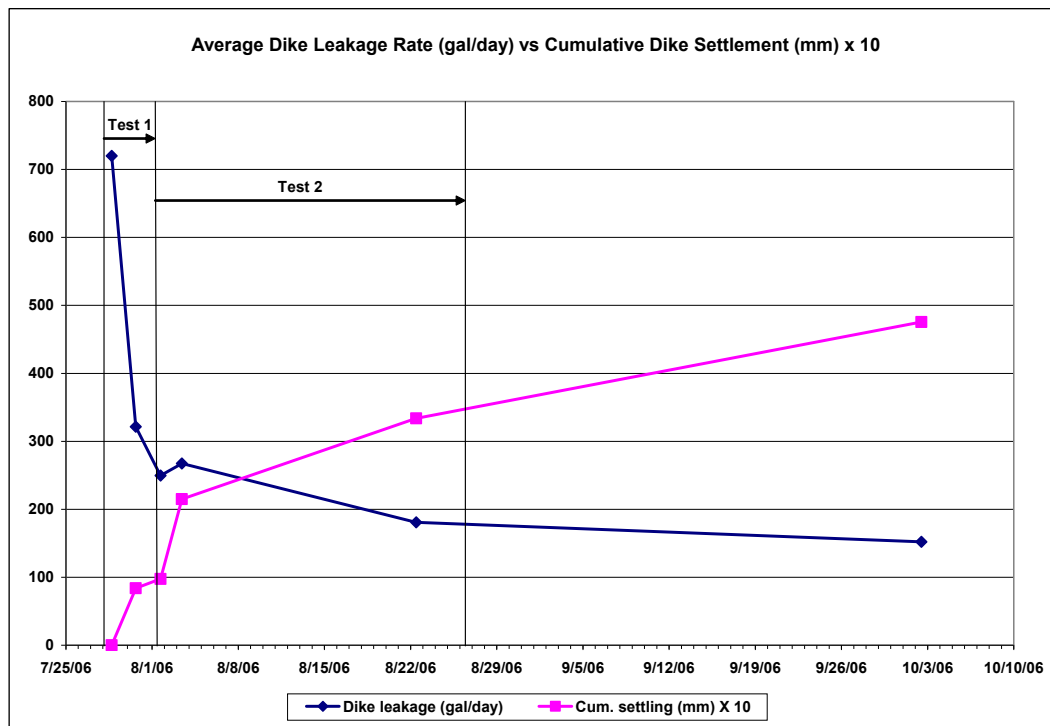
**Figure 26.** Plot of dike leakage and dike settlement over time.

A plot of average dike leakage rate (gal/day) against cumulative dike settlement (Fig. 25) indicates a potential relationship between the two variables. The plot suggests that the most significant electrokinetic and electrochemical effects (dewatering and consolidation via aluminum ion addition) had occurred by the early days of Test 2 (**NOTE:** in order to plot both variables at the appropriate relative chart scale, cumulative dike settlement, in mm, was increased by a factor of 10).

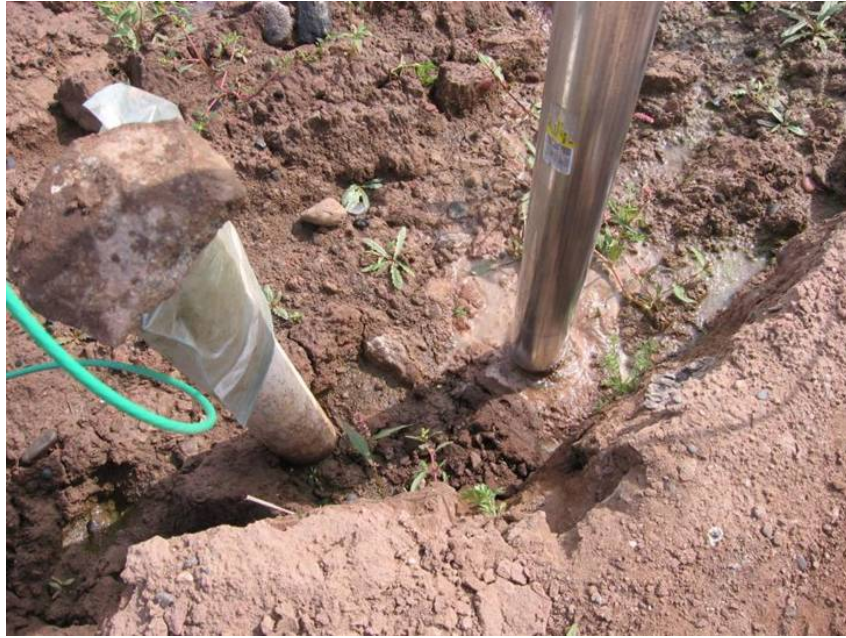
**Figure 37.** Water drawn to new cathode (C2-4) on sump side of dike, September 21, 2006, Test 3a. Note PVC piezometer (P3) to the left.

This configuration demonstrated how water was actively moving to the cathodes. Figures 37 and 38 illustrate this clearly, and show how water was emerging around the cathodes where they entered the dike surface.

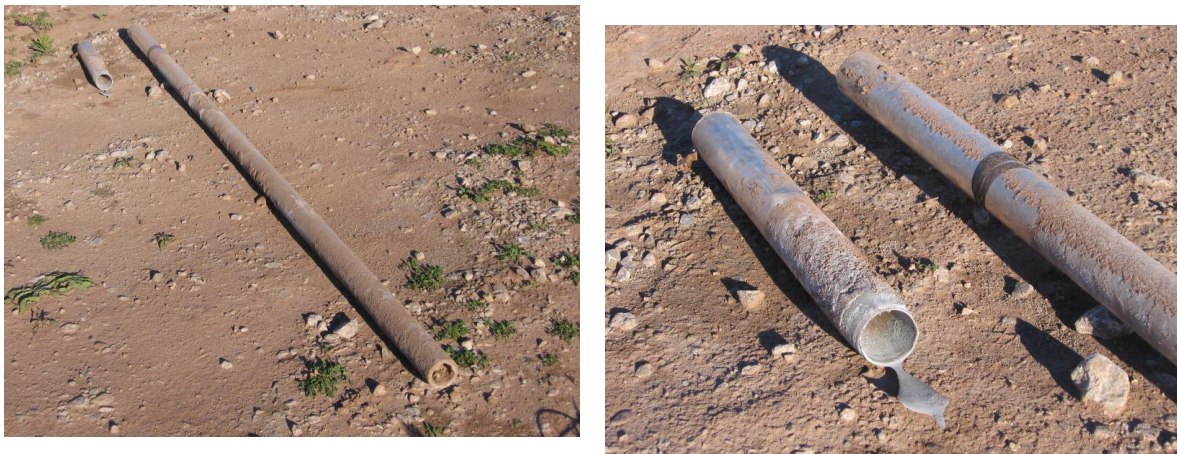
**Figure 39.** Depleted aluminum anode compared to an intact anode.

Lastly, chemical and/or mineralogical analysis of the dike soil would have shown to what degree aluminum was delivered to the dike by the anodes, because significant electrochemical depletion of the aluminum anodes occurred, as shown in Fig. 39.

Other indicators and evidence of the technology's impact include: changing piezometer levels over time; clearly visible movement of water to both the horizontal and vertical cathodes; and significant electrochemical deterioration of the aluminum anodes.
